No. 16

Importance of Range instrumentation when the unexpected happens.

EXPERIMENT OVERVIEW

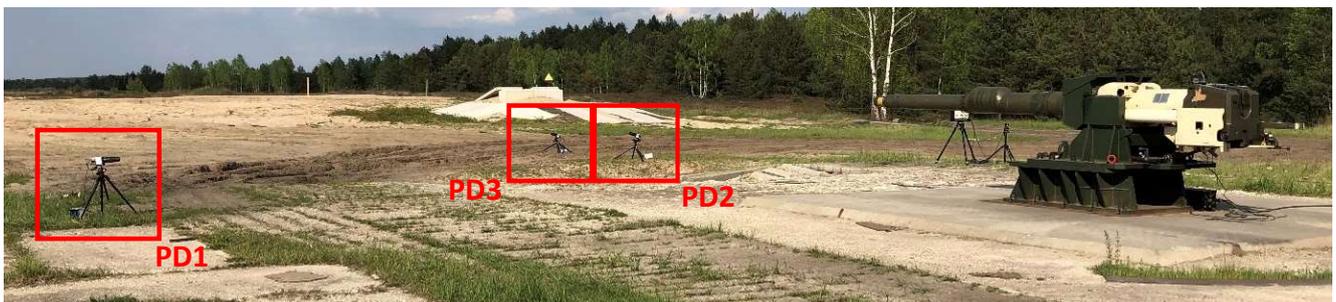
The APFSDS projectiles were launched using a smooth bore 120mm fixed gun firing horizontally at a target 500m away.

The SI Tracker 2 was located 50m downrange of the muzzle and 50m to the left side of the firing line. The Tracker camera view started 2m ahead of the muzzle and was configured to follow the projectile for 100m.

To start the SI Tracker 2 mirror sweep, an SI-OT3 optical trigger was used as a flash trigger (PD1) to detect the muzzle flash. This was located 7m to the left of the muzzle. Two additional OT3 Optical triggers were located at 5m (PD2) and 10m (PD3) locations downrange of the muzzle and 3m to the

right of the flight path. These two units were used to detect the actual position and measure the velocity of the projectile after launch to allow immediate mirror correction for any differences between the predicted and actual muzzle velocity.

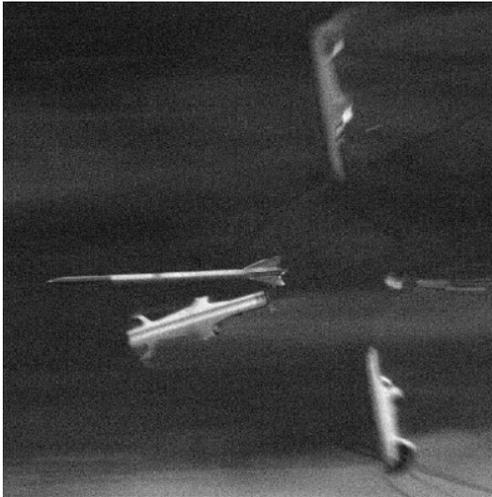
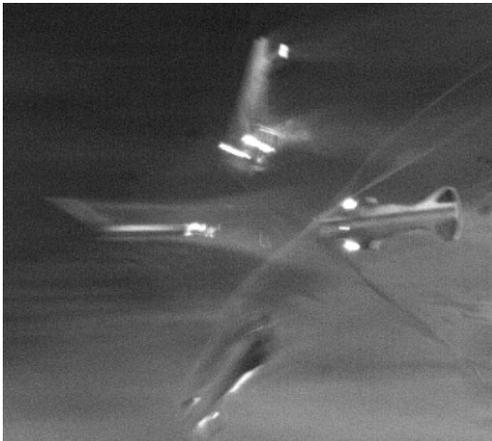
10m (approx.) from muzzle

The images below show sabot separation and APFSDS projectiles approximately 10m and 45m downrange of the muzzle. The top images show correct separation when using propellant at a lower temperature. The second pair of images show asymmetric sabot separation and projectile break up at 10m and the remaining part (tip behind remains of body) yawing significantly at 45m downrange.

The higher pressures created by the higher temperature propellant most likely caused failure of the sabot within the barrel, and the projectile break up immediately beyond the muzzle. The SI Tracker 2 unit was able to measure the velocity and position of the projectiles (intact and failed) well enough to capture the full 100m flight as intended. This can help establish the failure mechanism created by the higher temperature propellant and the subsequent effect on projectile trajectory.
